Austin MG

August, 1975

MIDGET 1500 CC OVERHEATING

MIDGET 1500 CC

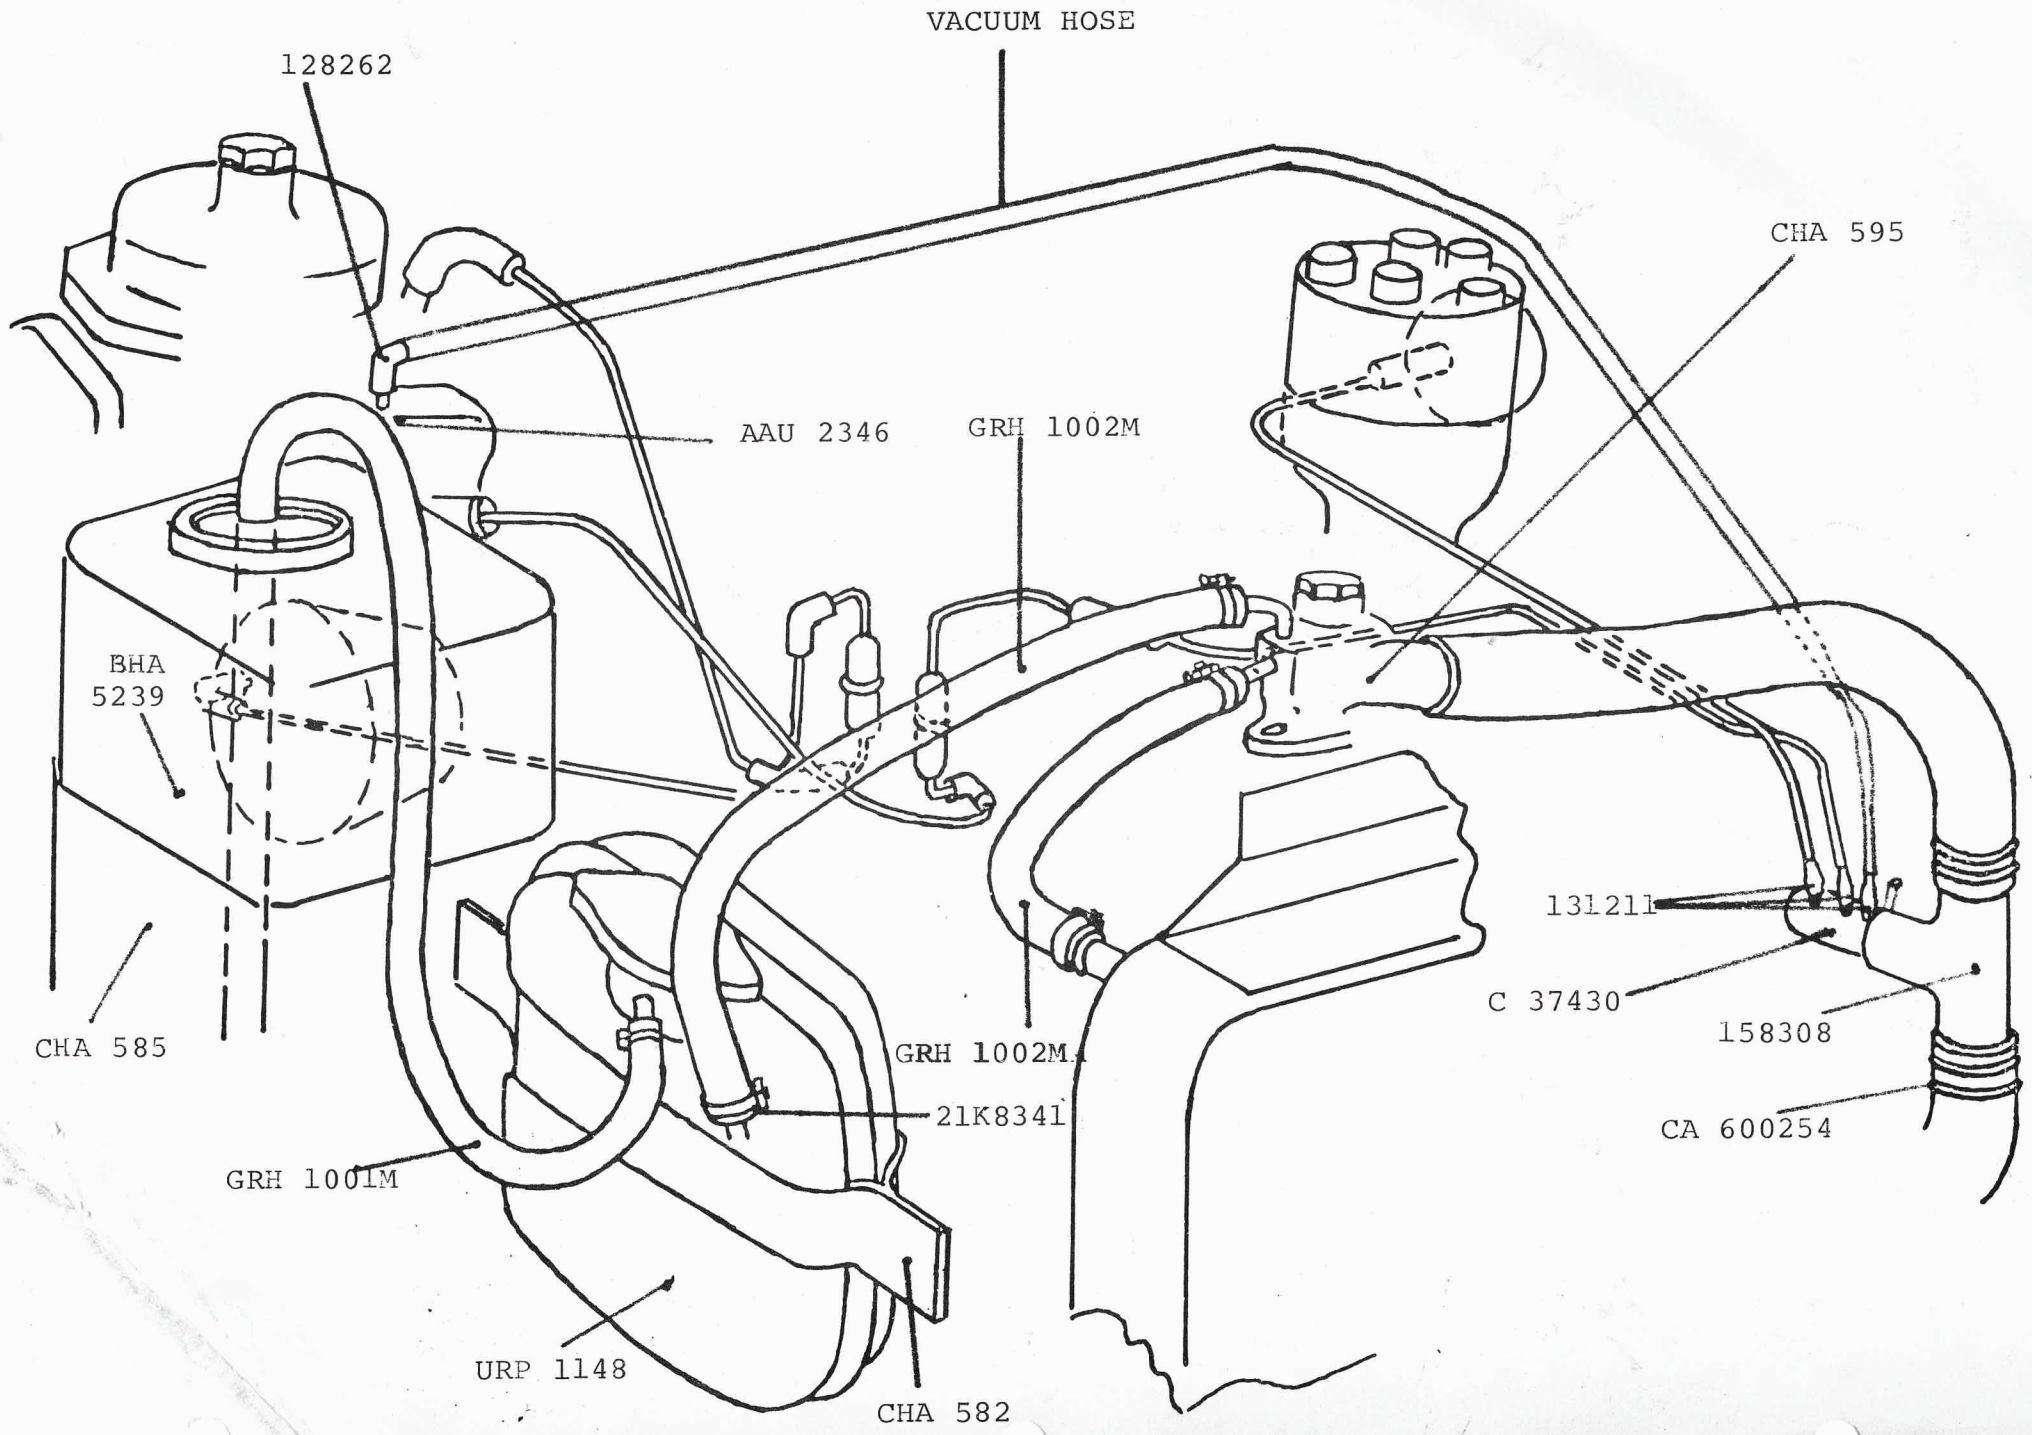
Where instance of severe overheating occurs on 1975 MG Midgets, the following modifications should be carried out.

1. Remove and discard the front number plate bracket and plinth assembly. Relocate and mount the front number plate to the center of the bumper, using self-tapping screws.
2. Reposition both horn assemblies by simply bending the mounting bracket upwards and through 90°.
3. Install thermo-vac switch, Part No. C-37430 with 'T' sleeve adaptor, Part No. 158308 in the top radiator hose as shown.

NOTE:- (Remove approximately 1 1/4" from the existing hose to accomodate the 'T' sleeve.)

4. Remove the decell valve from the carburettor and replace with externally vented valve, Part No. AAU-2346.
5. Remove and discard the existing expansion tank and replace with metal type, Part No. URP-1148, using the existing bolts and spacers and new brackets supplied, Part No. CHA-582.

NOTE:- The pressure cap supplied with the metal tank has a double seal, and therefore is not interchangeable with the original cap which should be discarded.

6. Install bracket, Part No. CHA-585 and no-loss bottle, Part No. BHA-5239, utilizing the right-hand upper shock absorber support plate bolts.
7. Remove and discard the thermostat housing and install modified housing, Part No. CHA-595.

8. Connect the vacuum and water hoses as shown in overall illustration.

NOTE:- Vacuum hose will have to be cut to length.

9. Pressure test system for any leaks.
10. Replace temperature gauge assembly, Part No. AAU-2641. Please note all displaced parts should be returned to your Distributor intact.
