# TECHNICAL SERVICE BULLETIN

NO. 77-A-6

**SUBJECT:**  
EXHAUST DOWN PIPE AND FLANGE GASKET FAILURES

**MODELS:**  
Spitfire

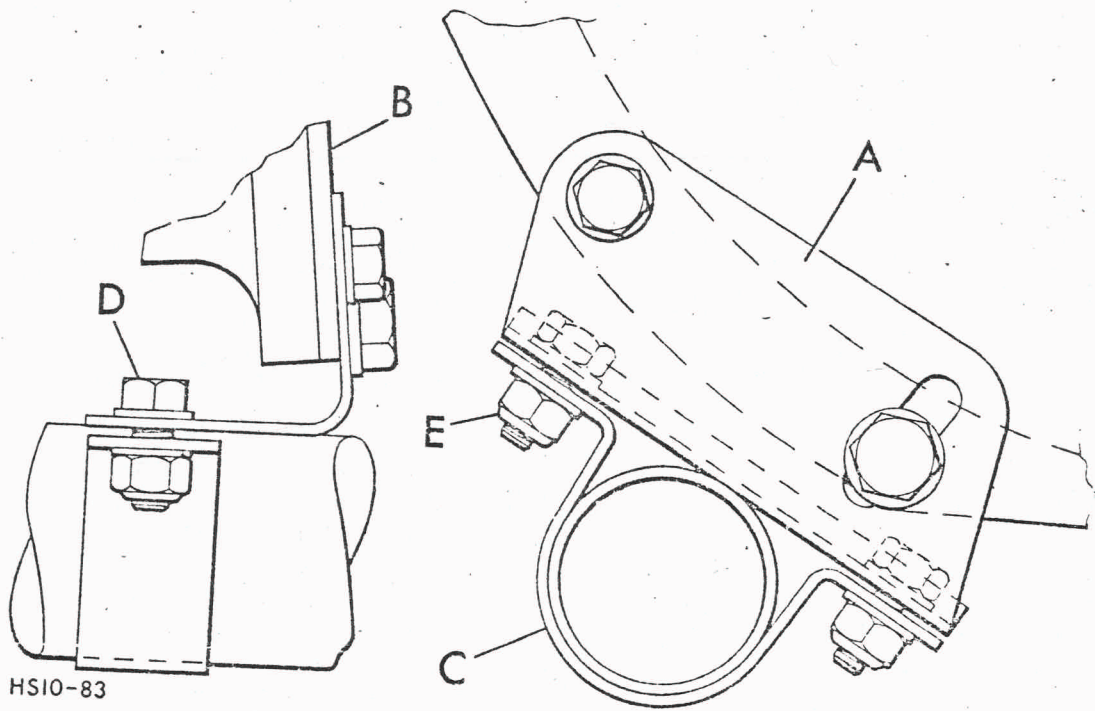
An extra support bracket and clip were introduced on production at VIN #FM-63214. The purpose of this support bracket is to prevent exhaust down pipe and/or exhaust gasket failure.

- 1 - Attach the support bracket "A" (part #UKC9171) to the forward side of the engine back plate "B" (as illustrated) using the two existing bolts. Do not tighten the bolts at this stage.
- 2 - Fit the appropriate clip "C" (part #UKC9611 or part #UKC9172) to secure the exhaust pipe to the support bracket.
- 3 - Tighten the clips securing bolts "D" and "E" (part #HU0806 and #143802).
- 4 - Tighten the support brackets securing bolts.
